Interim Report
for the period
November 1988
to June 1990

Aluminum Alloys for Cryogenic Tanks: Oxygen Compatibility Volume 1.

National Institute of Standards and
Technology
325 Broadway
Boulder CO 80303

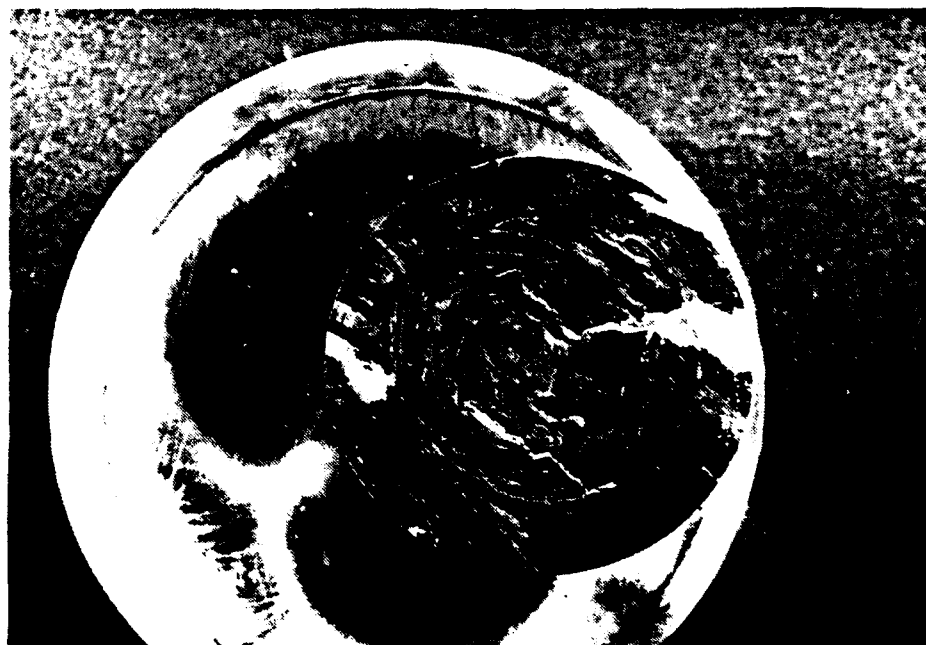
Figure I.5.5a. The "fluid-like" flow of material observed in 2090-T81 specimen on a plane polished very near the impacted surface of the specimen.

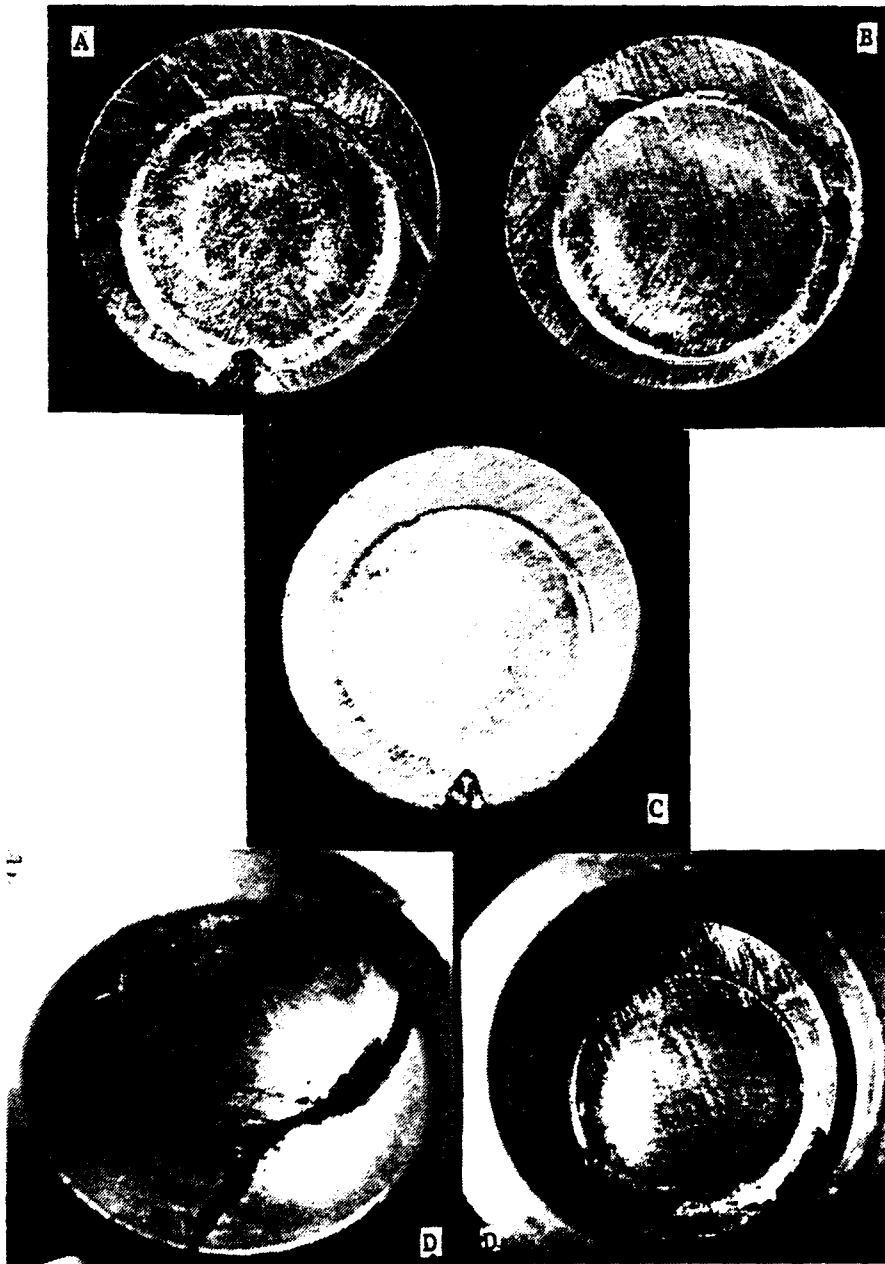
Figure I.5.19. The four 2219 specimens that reacted during LOX testing were: (a) #12, (b) #15, (c) #20, and (d) #19.

The morphology and apparent initiation site varies for the four reactions. The reaction in specimen 12 (Figure I.5.19a) initiated somewhere near the bottom of the shear face. There is a crack or delamination at the bottom of the V shaped reacted area that is visible for several millimeters along the circumference of the final striker-pin mark. The reaction is deepest near the bottom of the V and its surface has indentations that are similar in size and shape to the grains in the 2219 alloy. The surface of the reaction forms a

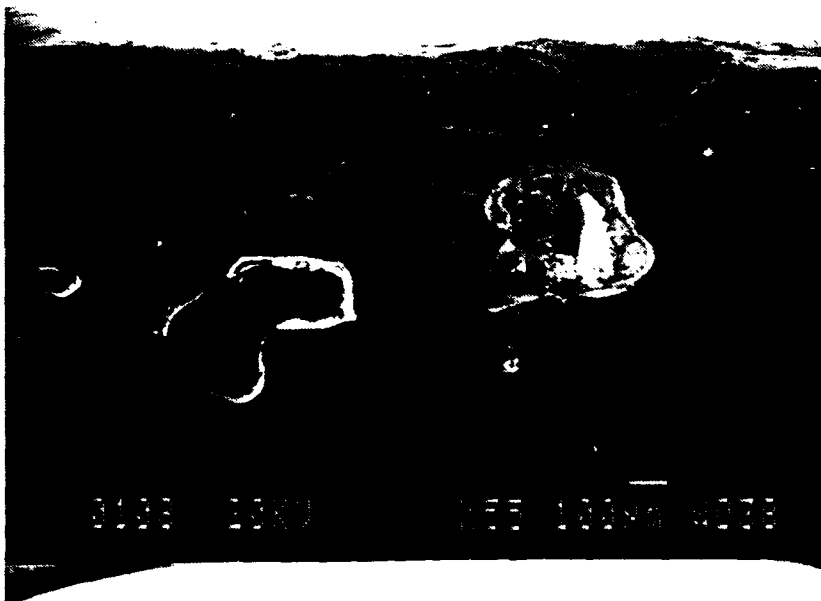
Damaged area just below bevel
(Cr-rich deposition hole)

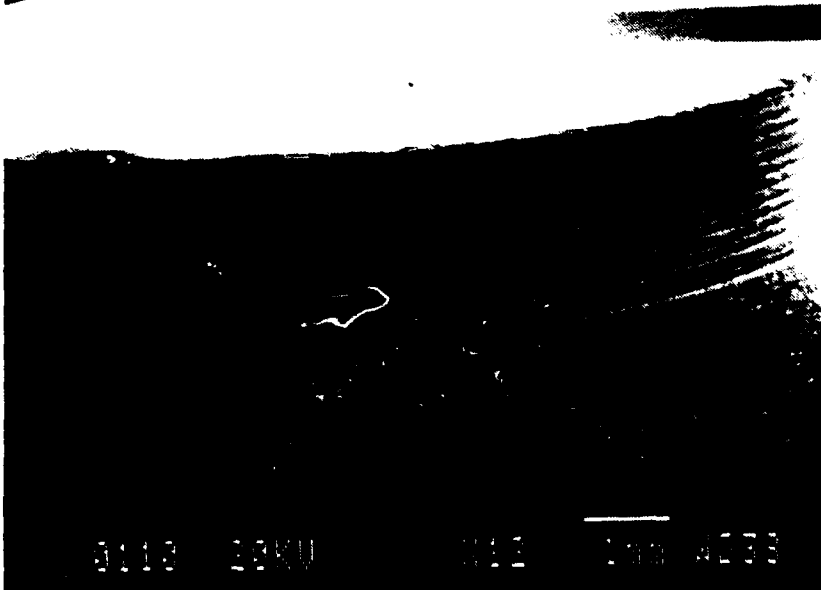
Striker pin surface and side
Spattered Al-rich oxide.

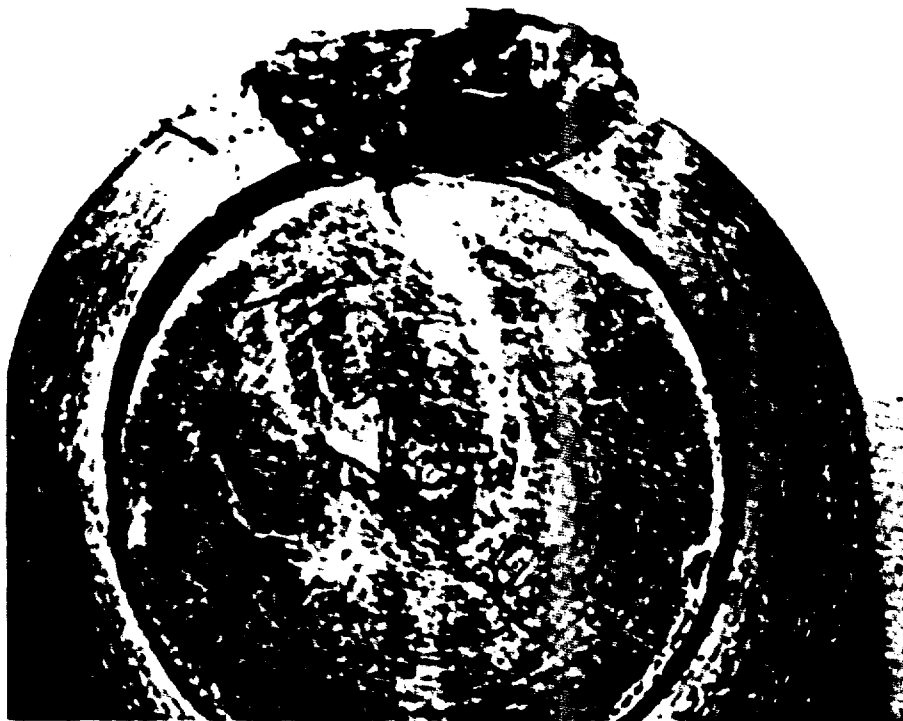
Figure I.G-4. Alloy 2090-T81 at 100 psi (LOX), $\frac{1}{8}$ inch thick specimen (#8) from $\frac{3}{4}$ inch plate.
